Date	Category Descriptions	Partner Manual Reference	Hours
12/09/01	Empennage Reamed Horizontal Stabilizer Bushings	IV-3	1.50
<p>I reamed seven bushing locations to .4375 where elevator attaches to horizontal stabilizer. The proximity of the locations to structural tubing made it difficult to position the reamer for turning. I modified the reamer by threading the end (3/8") and attaching an allthread rod and 'T' handle. This provided the reach needed.</p>			
12/16/01	Empennage Prepared for rib mounting	IV-7	1.00
<p>I finished reaming the 3/16" holes in the horizontal stabilizer, elevator, and fuselage attach points. I then marked the horizontal stabilizer and elevator for installation of the plywood ribs.</p>			
12/18/01	Empennage Glued ribs to elevator	IV-8	2.50
<p>I fitted and attached ribs to elevator and horizontal stabilizer. Elevator is complete. Outboard ribs in stabilizer are complete. Inboard ribs require additional preparation to fit around structural tubing. The adhesive used was Hysol structural adhesive (epoxy) with cotton floc as a filler. Cure time is three days at 77 degrees.</p>

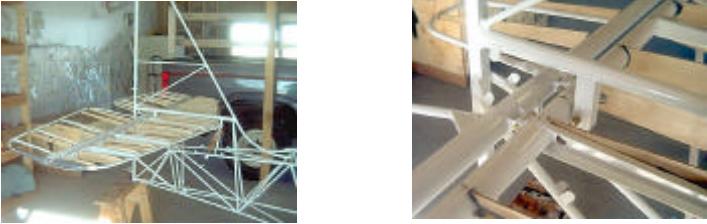
Date	Category Descriptions	Partner Manual Reference	Hours
1/06/02	Empennage Attached Elevator Elevator is attached to stabilizer. Attachment made at six hinge positions. The hinge tabs on the elevator seem to pinch the bushings on the stabilizer. This makes the elevator movement very stiff.	IV-35	1.00

1/08/02	Empennage Adjust Elevator Hinge Fit After consulting with Skystar technical support, I decided that the elevator hinges were providing too tight a fit. I removed the hinge pins and filed excess powder coat off the tabs and bushings. The tabs were then spread and the elevator reinstalled.	IV-35a	1.25
1/09/02	Empennage Mounted Trim Motor The electric trim motor was attached to the fuselage and the horizontal stabilizer. The rod end fit on top is very tight with washers sandwiched in.	IV-44	1.50

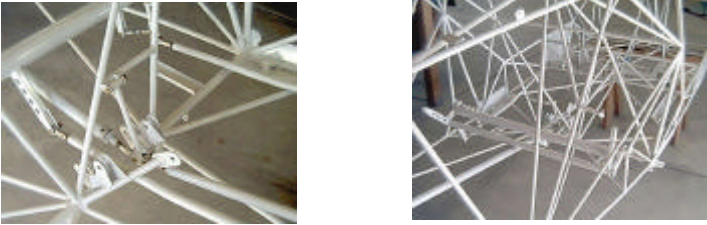
Date	Category Descriptions	Partner Manual Reference	Hours
2/03/02	Flight Controls Flaperon Mixer I mounted the flaperon mixer assembly to the airframe. The assembly was then connected to the control column and flap handle with push rods.		2.50

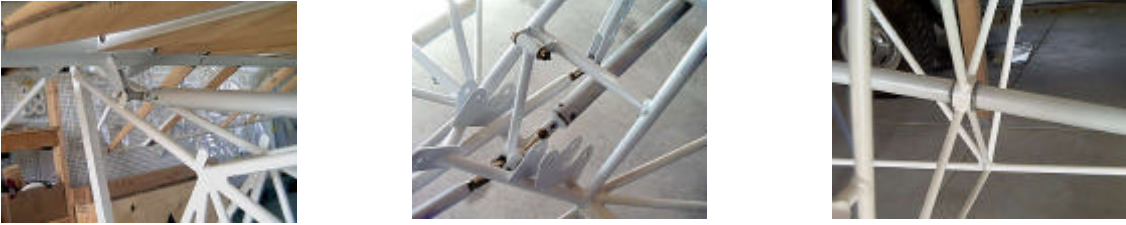
2/04/02	Fuselage Primed Elevator Push Rod Elevator push rod has been primed with epoxy primer.		1.50
2/11/02	Flight Controls Attached Elevator Push/Pull Rod The elevator push/pull rod was assembled and attached to the control column idler and the elevator bellcrank. Rod ends were constructed using structural adhesive and rivets. The guide bushing housing about half way along the rod required moderate filing and sanding to fit the plastic bushing. I also drilled center holes (1/16") in the rudder adjust and flap handle detent pins to allow insertion of a tiny roll pin. My earlier efforts at this were fruitless and resulted in three broken drill bits. I was able to get the holes drilled by using a cobalt bit and making a jig out of oak to align the pin and the drill bit.		3.25

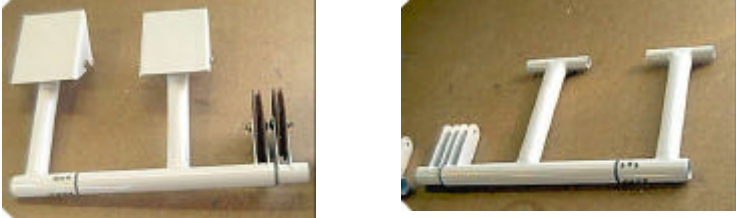
Date	Category Descriptions	Partner Manual Reference	Hours
2/27/02	Flight Controls Rudder Pedals		2.25
<p>The rudder pedal pivots were attached to the torque tubes with rivets. Cable pulley and guard were mounted on each horn. The rudder pedals were attached to the pivot tubes.</p>

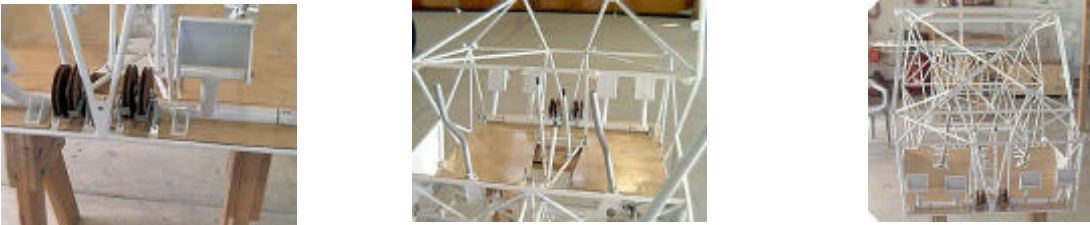
3/04/02	Flight Controls Mount Rudder Pedals in Cockpit		4.00
<p>The rudder pedal assemblies were mounted to the cockpit floor. Bolts through the brackets attach to the steel weldments. Return springs are installed/</p>

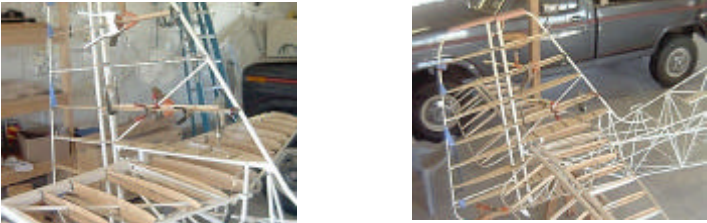
Date	Category Descriptions	Partner Manual Reference	Hours
3/11/02	<p>Empennage Airfoil Ribs Installed in Rudder</p> <p>The plywood ribs that give the rudder an airfoil shape were installed. Previously installed ribs in the vertical stabilizer recieved stiffeners.</p>		3.25

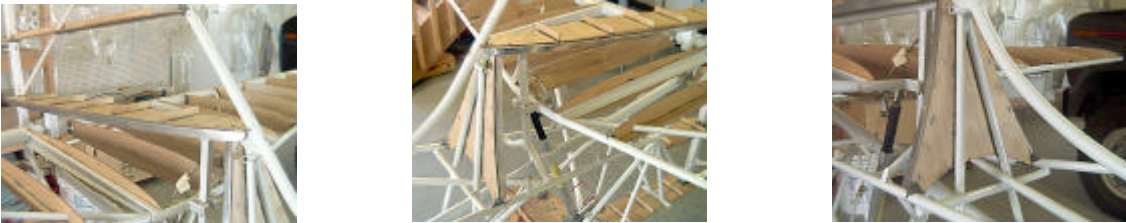
3/12/02	<p>Empennage Reinforced Ribs</p> <p>Reinforcement strips were glued to the ribs in the rudder. Aluminum angle was cut, notched, and drilled to fabricate the tail access panel mounting plates.</p>		2.00
3/14/02	<p>Empennage Varnish Ribs</p> <p>The plywood ribs in the rudder and vertical stabilizer received their first coat of epoxy varnish.</p>		1.00
3/15/02	<p>Empennage Attach Angles for Cover</p> <p>The aluminum anlge pieces which will be used to attach a cover over the tail root were installed. The forward bulkhead for this area was also installed.</p>		1.50

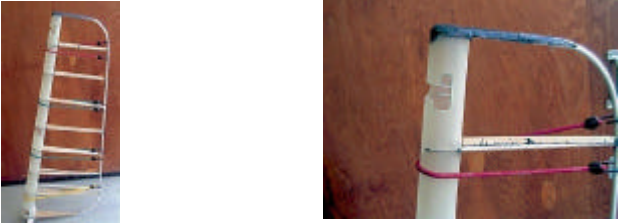
3/17/02	<p>Empennage Rudder Leading Edge</p> <p>The rudder leading edge is made of fiberglass. The piece was fitted and slots cut to permit access to the rudder hinge bolts. The leading edge was bonded in place. The top of the rudder was formed by shaping foam blocks and sealing the foam with epoxy. The rudder stop tabs were filed to permit 25 degrees of rudder travel in each direction.</p>		3.00

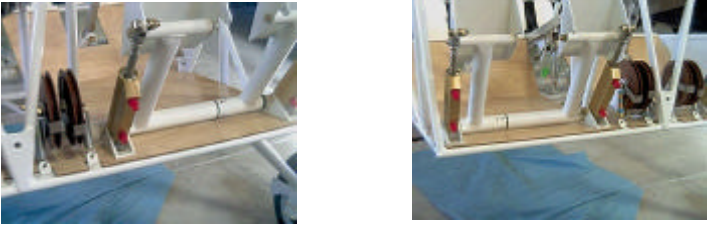
Date	Category Descriptions	Partner Manual Reference	Hours
4/22/02	<p>Systems Brake Master Cylinders Brake master cylinders were installed. Skystar provided Matco cylinders instead of Cleveland cylinders.</p>		1.50

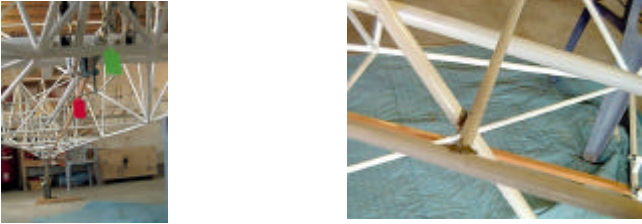
4/22/02	<p>Fuselage Longeron and Stringers The wood longeron was installed on the belly of the fuselage. Three aluminum tube stringers were installed between the aluminum longerons. Attachment was accomplished with epoxy and safety wire.</p>		2.50

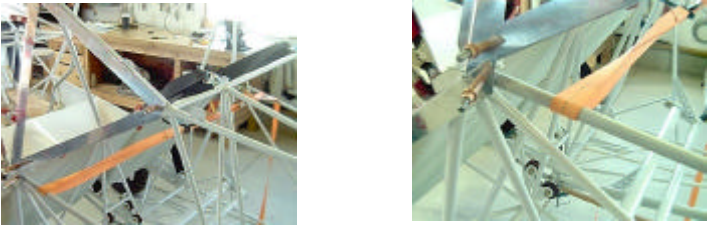
4/30/02	<p>Fuselage Pilot Door Trim I attached the aluminum angles that act as trim on the pilot's side. Angles were also attached around the quarter window. Attachment was performed using epoxy reinforced with rivets at each overlap.</p>		1.50
